Arboricultural Condition Report

Fremantle Road Recreation Ground
Sandgate
Kent

18th September 2024

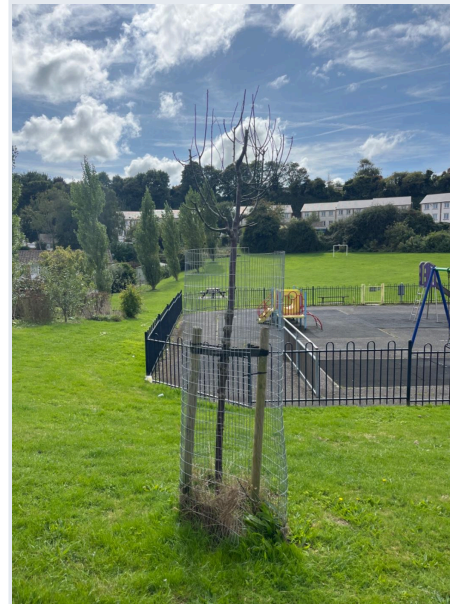
Cherry species Tree ID #1

| Physiological Condition: | Dead |
| Structural Condition: | Poor |
| Comments: | Tree is dead. |

| Recommendations: | Remove and replant with a new tree. |
| Priority: | Priority 2 - 3 months |

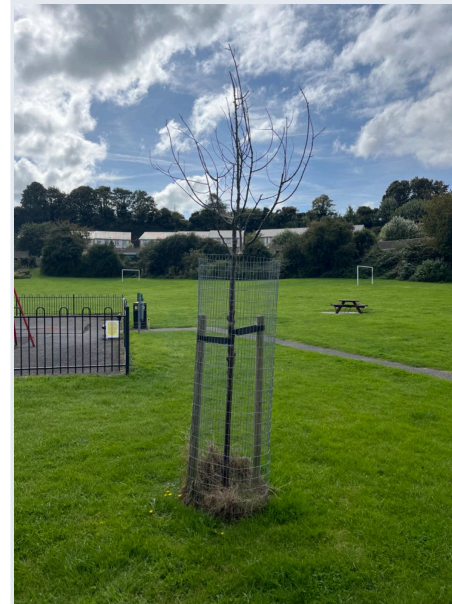
Cherry species Tree ID #2

| Physiological Condition: | Dead |
| Structural Condition: | Poor |
| Comments: | Tree is dead |

| Recommendations: | Remove and replant with a new tree. |
| Priority: | Priority 2 - 3 months |

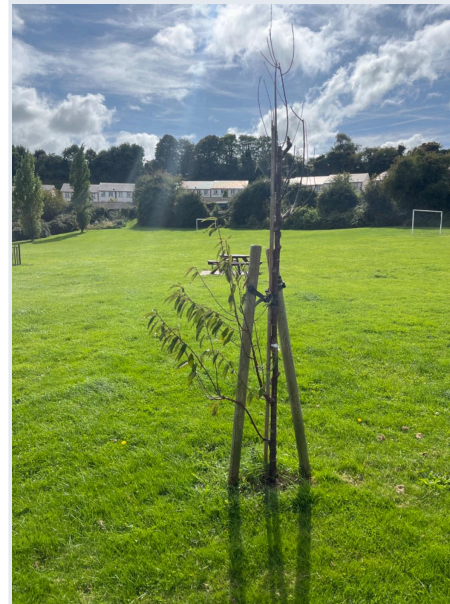
Cherry species Tree ID #3

| Physiological Condition: | Poor |
| Structural Condition: | Poor |
| Comments: | Tree is predominantly dead. |

| Recommendations: | Remove and replace with a new tree. |
| Priority: | Priority 2 - 3 months |

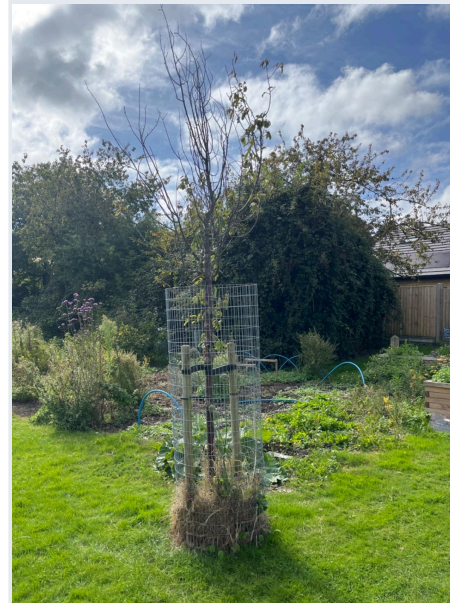
Cherry species Tree ID #4

| Physiological Condition: | Poor |
| Structural Condition: | Poor |
| Comments: | Tree is predominantly dead. |

| Recommendations: | Remove and replant with a new tree. |
| Priority: | Priority 2 - 3 months |

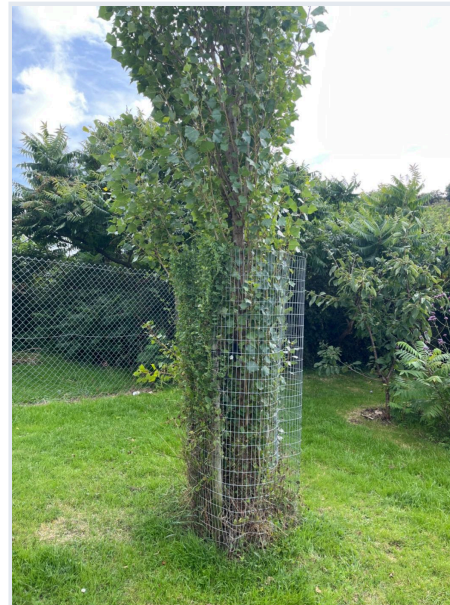
Lombardy poplar Tree ID #5

| Comments: | The protective cage that surrounds the tree is full of weeds. |

| Recommendations: | Remove protective cage and remove all weed growth from within to maintain a weed free base around the tree. The tree is maturing well and is considered established and independent within the landscape and therefore the protective cage need not be used. Retain the supporting stakes and tie for one more year before removing. |
| Priority: | Priority 2 - 3 months |
