Invicta Arboriculture
Tree and Woodland Consultancy

Arboricultural Condition Report

Sandgate Recreation Ground
Military Road
Sandgate
Kent

18th September 2024

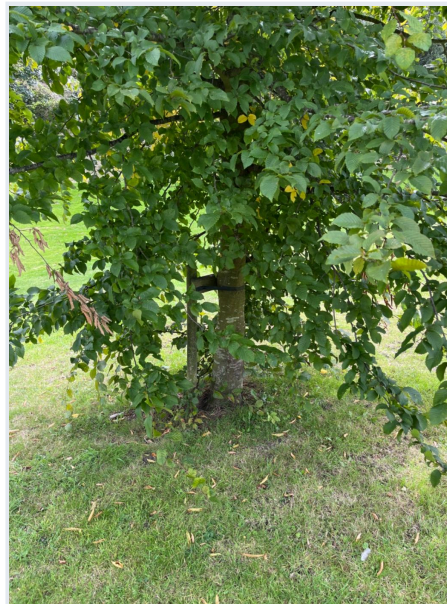
Hornbeam Tree ID #1

Common Name:	Hornbeam
Scientific Name:	Carpinus betulus
Tree Height [m]:	6
Life Stage:	Semi-mature
Physiological Condition:	Good
Structural Condition:	Good
Comments:	The tree, which is considered to be fully established and independent within the landscape still has the stakes and tie attached to it, which will begin to bind in to tree if left.
Recommendations:	Remove stakes, crossbar and tie.
Priority:	Priority 2 - 3 months

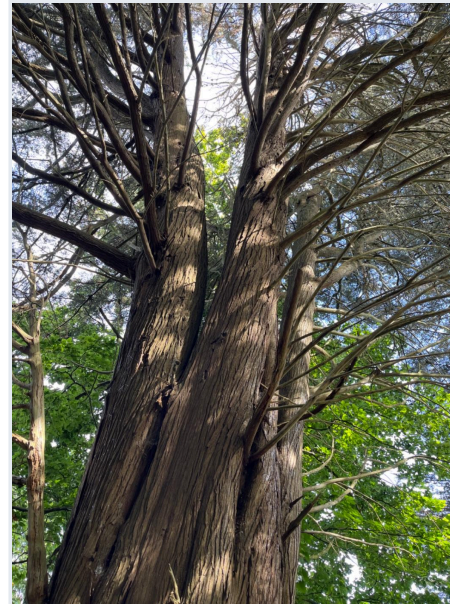
Monterey cypress Tree ID #2

Comments: Twin-stem tree forms from very low fork at three metres above ground level. The low fork supports a significant amount of weight. Partial canopy separation is now evident and is indicative of possible movement within the fork.

Recommendations: Install non-invasive flexible restraints in accordance with either figure D.1 or D.2 BS3998:2010 Tree Work – Recommendations. Bracings with an eight tonne rating are recommended.

Priority: Priority 2 - 3 months

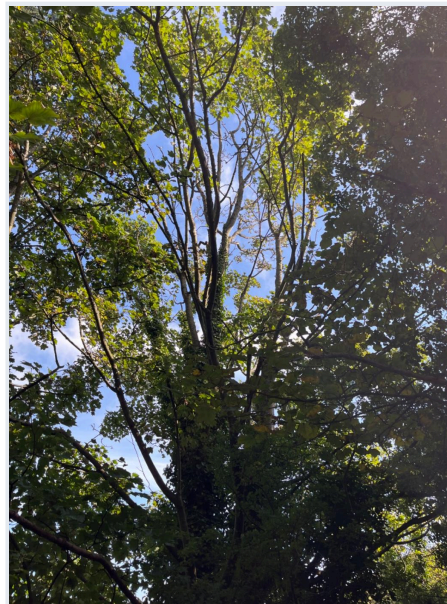
Sycamore Tree ID #3

Physiological Condition: Poor

Structural Condition: Fair

Comments: The tree is in a gradual state of decline with large diameter deadwood evident throughout its canopy. Cambial (bark) death and decay is evident within the main fork of the tree at 1.5 metres above ground level.

Recommendations: Fell to ground level

Priority: Priority 2 - 3 months

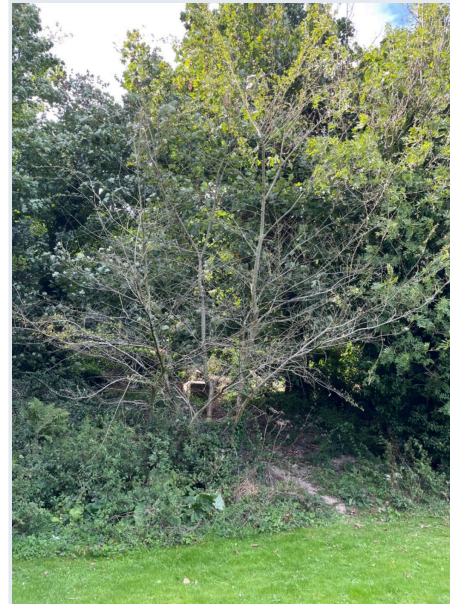
English elm Tree ID #4

Common Name:	English elm
Scientific Name:	Ulmus procera
Tree Height [m]:	8
Life Stage:	Semi-mature
Physiological Condition:	Dead
Structural Condition:	Fair
Comments:	The tree is dead.
Recommendations:	Fell to ground level.
Priority:	Priority 3 - 6 months

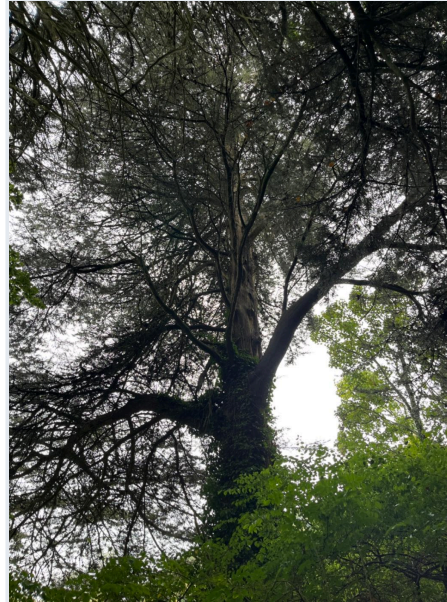
Monterey cypress Tree ID #5

Comments: A split is forming through the east-facing lateral branch arising at eight metres above ground level; the branch extends out above the adjacent basketball court. Woodpecker activity and minor decay is evident at sixteen metres above ground level on the western side of the central-most stem.

Recommendations: Reduce the height of the tree by a maximum of four metres. Reduce the length of the east facing lateral branch by a maximum of three metres.

Priority: Priority 2 - 3 months
